EXHIBIT 5 (PART 2 OF 2)

2.5.3 Cabinet Interior

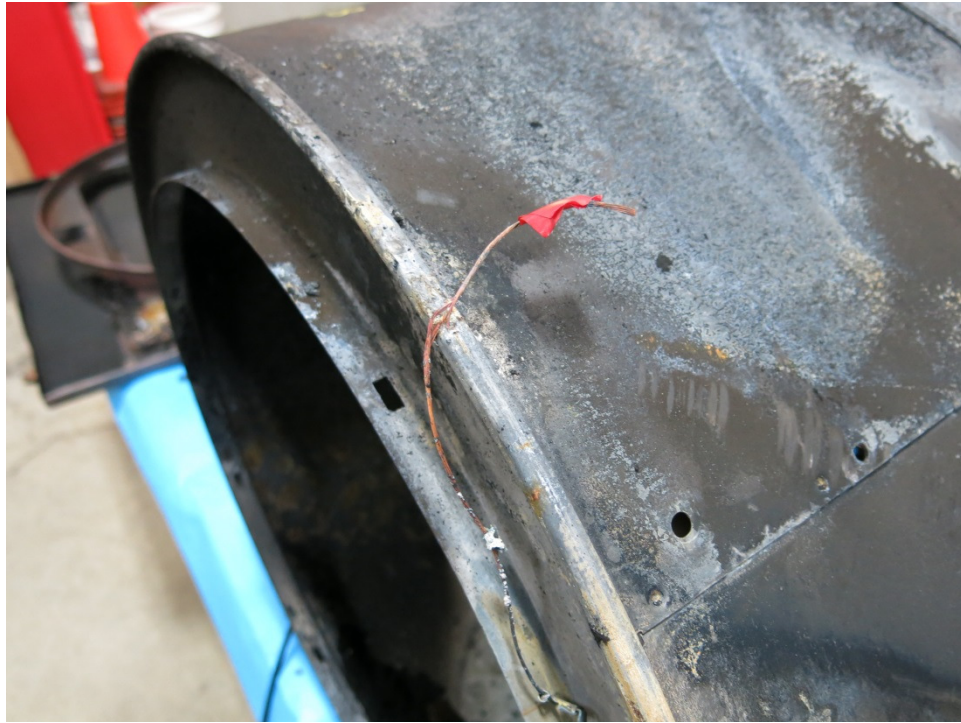
D14509-0413

Figure 33. Electrical lead from the door switch welded/affixed to the drum edge.

Electrical leads to the door switch were beaded and severed at the bulkhead entry inside the cabinet, and a conductor to the drum light was also melted. The severed line was broken at the front panel side. The door switch lead was welded to the drum edge. A smaller diameter cord at the front panel side of the cabinet was also melted. The observed electrical activity could be caused by fire attack, whether or not the dryer was running. Electrical activity, such as that caused by surface arc tracking or another component failure, is capable of igniting accumulated lint; however, giving the timing of the fire discovery and limited extent of damage, I was able to refute electrical fault while the dryer was running as a cause of the fire.

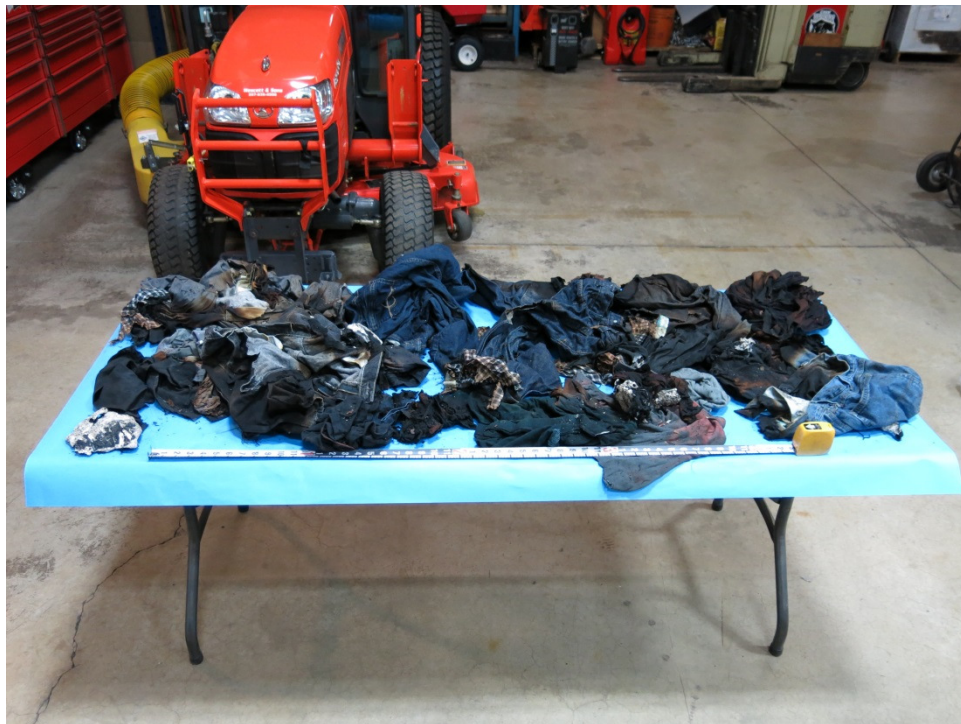
D14509-0158

Figure 34. Garments identified as laundry load, including jeans, underwear and t-shirts.

The most likely cause of this fire was spontaneous combustion of the drum load.

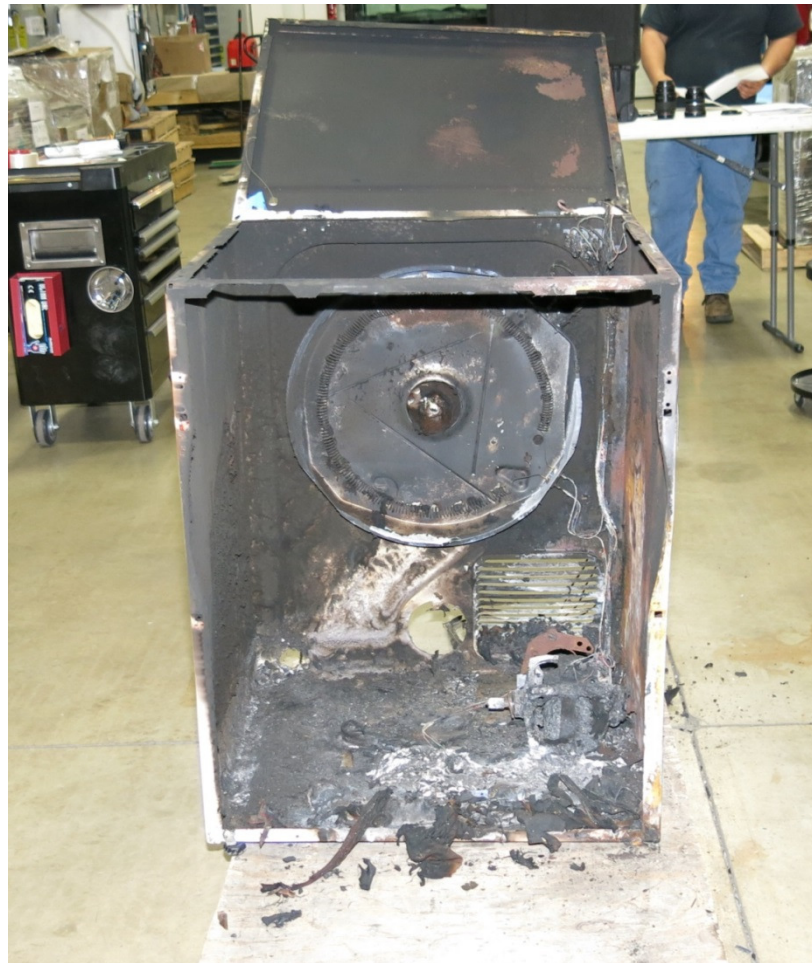
D14509-0363 cropped

Examination of the cabinet interior showed a thick coating of lint on the cabinet floor and walls (Figure 35). The coating of lint on the bottom left of the cabinet measured around 10 mm thick. There was also some debris likely associated with the drum load in the base of the cabinet. Plastic components including the air duct and blower assembly were partially consumed and melted to the base of the cabinet (Figure 36 and Figure 37). There was some unburned lint protected beneath the molten plastic and adhered to it. This heavy accumulation of lint is consistent with the interior exhaust tube being separated from the blower housing.

Figure 35. Dryer cabinet after removal of drum during my inspection.

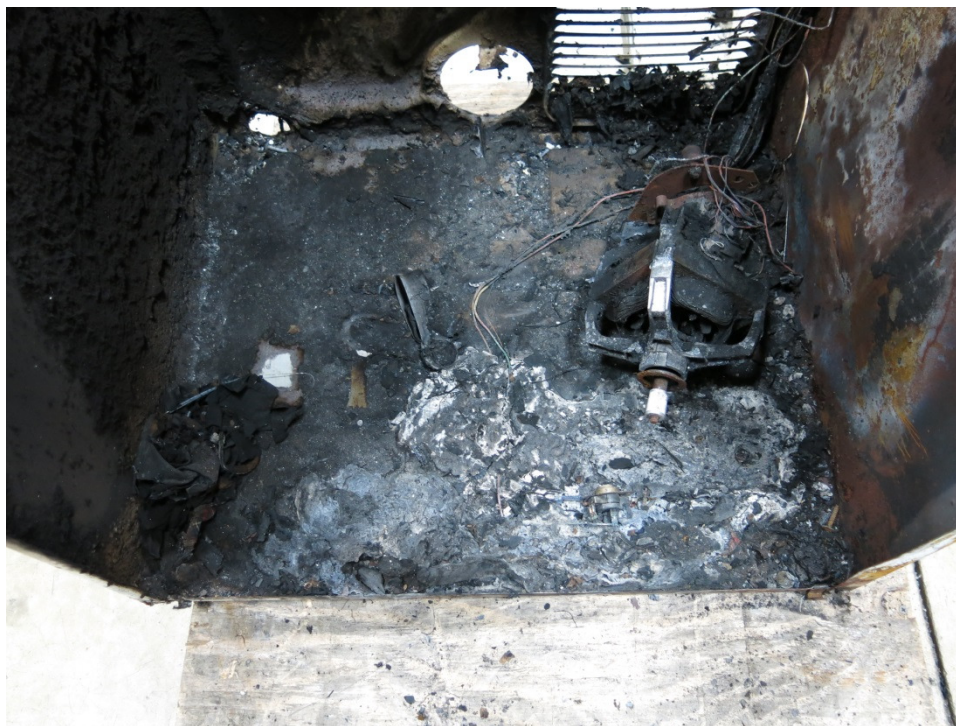
D14509-0536

Figure 36. Base of the cabinet.

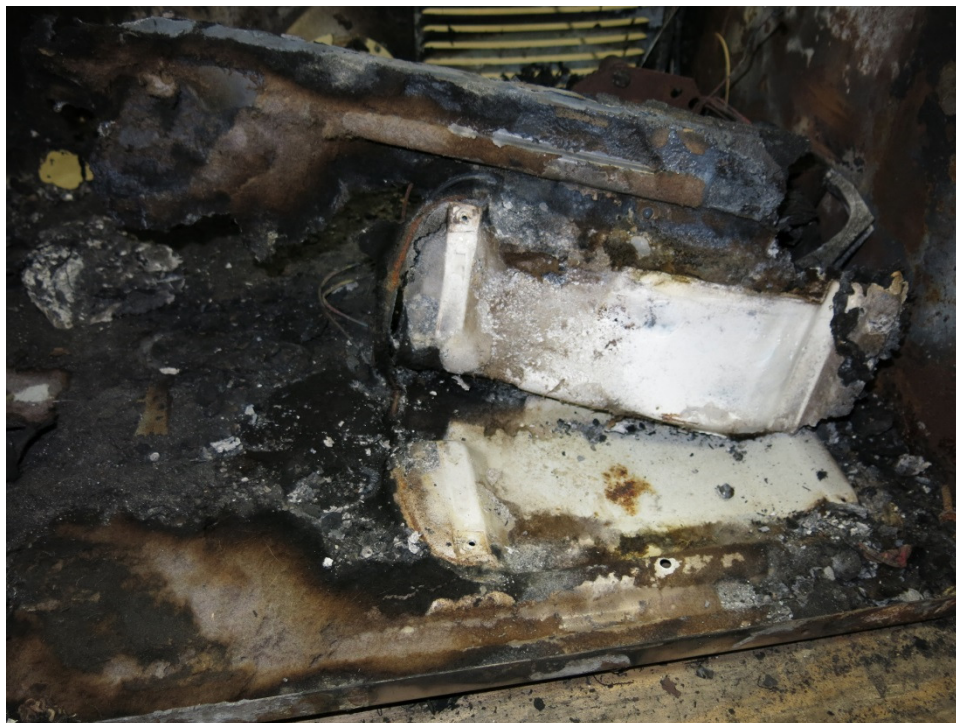
D14509-0542

Figure 37. Base of cabinet beneath melted plastic components.

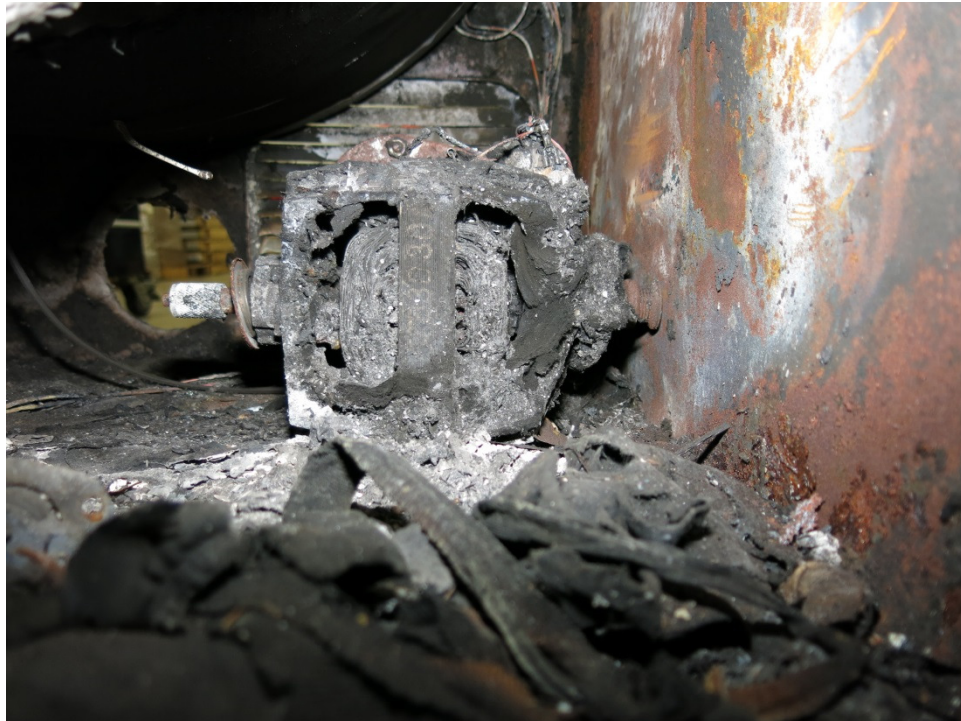
D14509-0362

The motor was found in the base, with lint adhered to it (Figure 38). Some of the windings had apparently melted. The shaft was seized and the centrifugal switch was immobile. Due to the magnitude of damage during the fire, I could not rule out an electrical or mechanical fault in the motor.

Figure 38. Motor with melted windings.

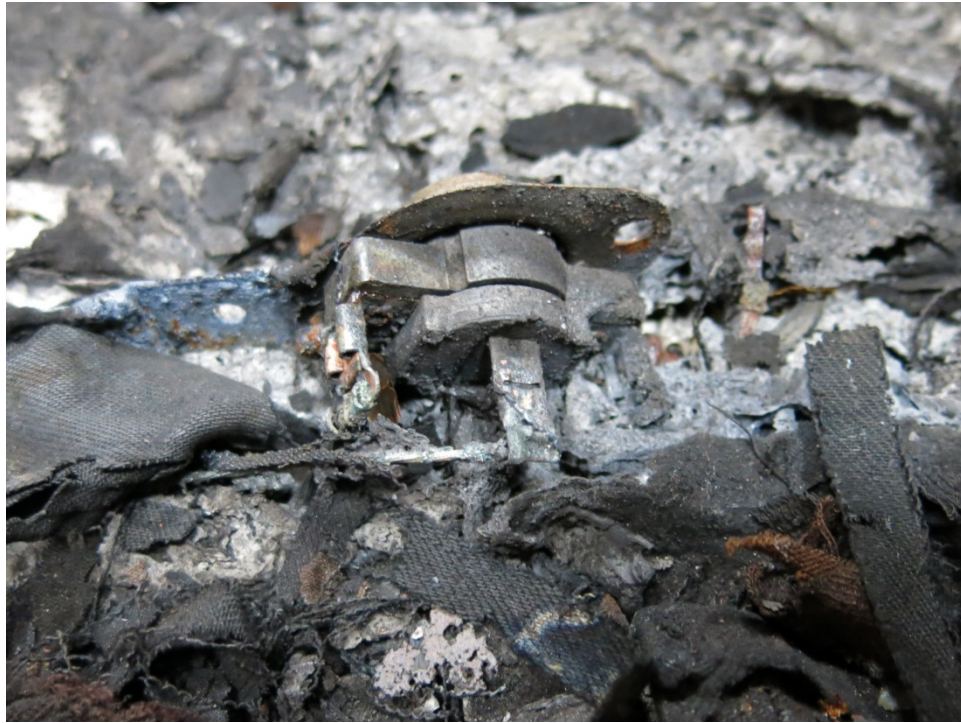
D14509-0399 cropped

The control thermostat was in the base of the cabinet, damaged by fire but mostly intact (Figure 39). The control thermostat was not functionally tested because of the fire damage. The high-limit thermostat was found in place at the one o'clock position on the heater pan, with some lint adhered to it and around it (Figure 40). The high-limit thermostat successfully operated when functionally tested. The contacts exhibited signs of previous activity, but were not welded (Figure 41). The thermal limiter (also in Figure 40) was found in place but had no continuity when tested, suggesting that it had opened at some point during the fire.

Figure 39. Control thermostat found in the base of the dryer cabinet.

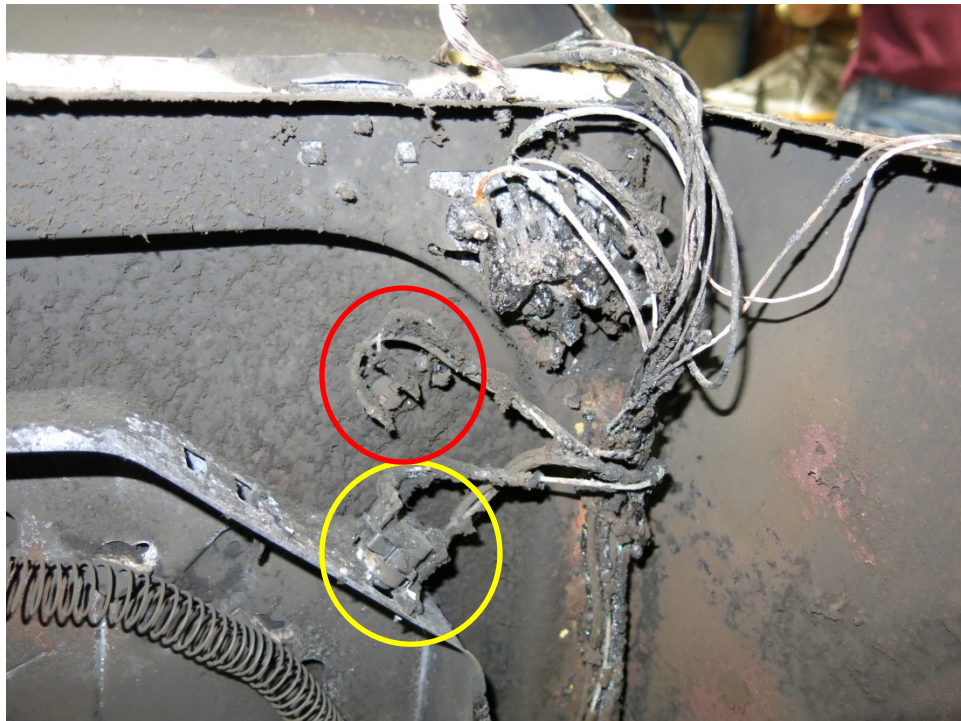
D14509-0500

Figure 40. High-limit thermostat (circled in yellow) and thermal limiter (circled in red).

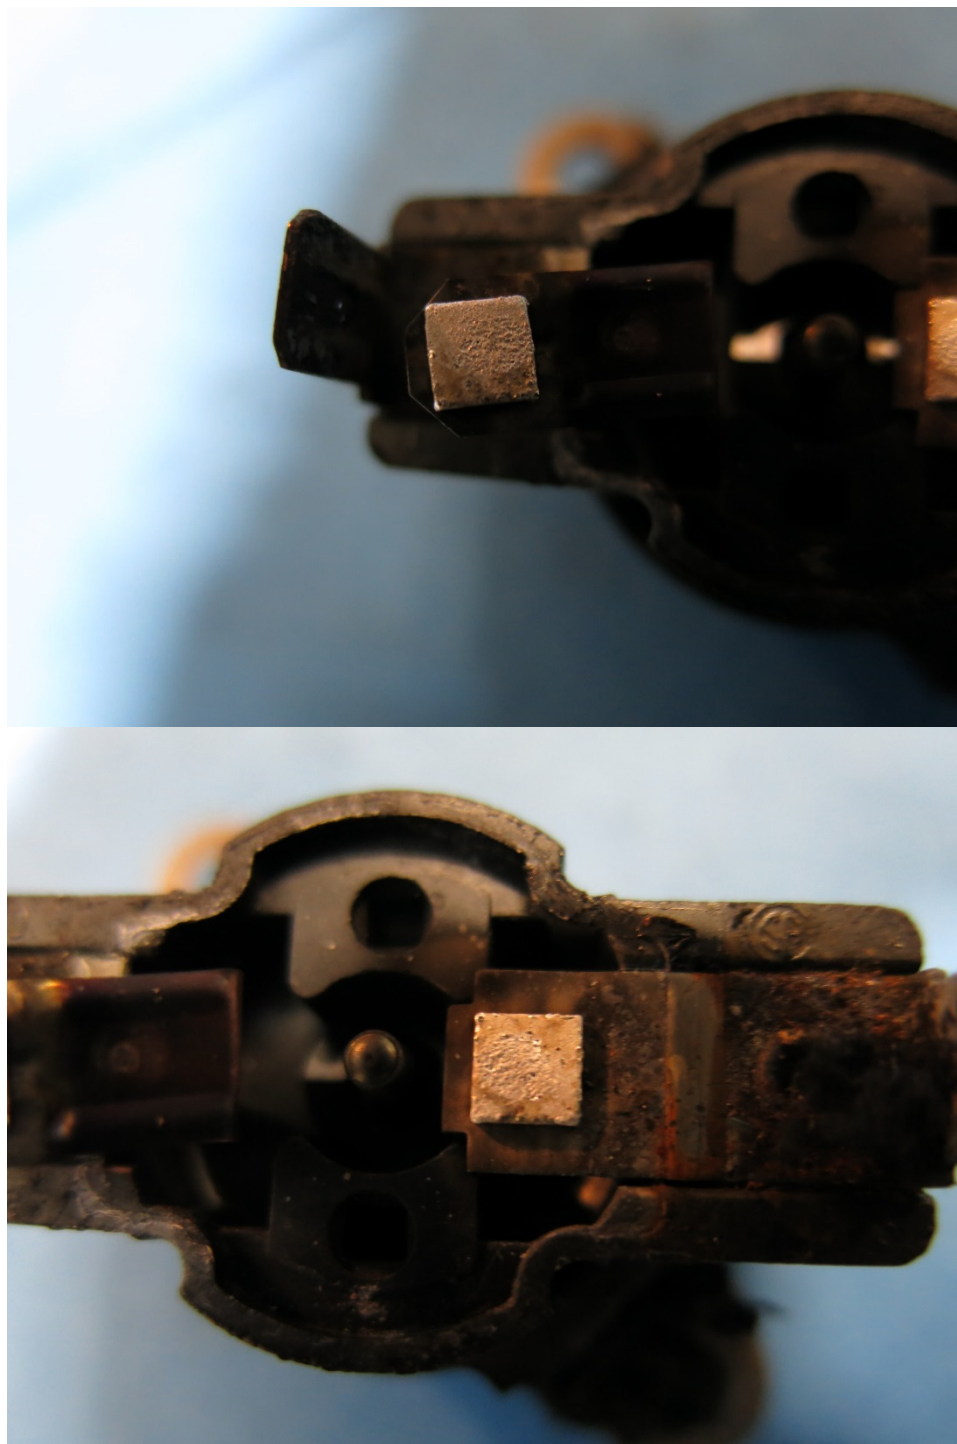
D14509-0534 and D14509-0535

Figure 41. Contacts of high limit thermostat showing some pitting.

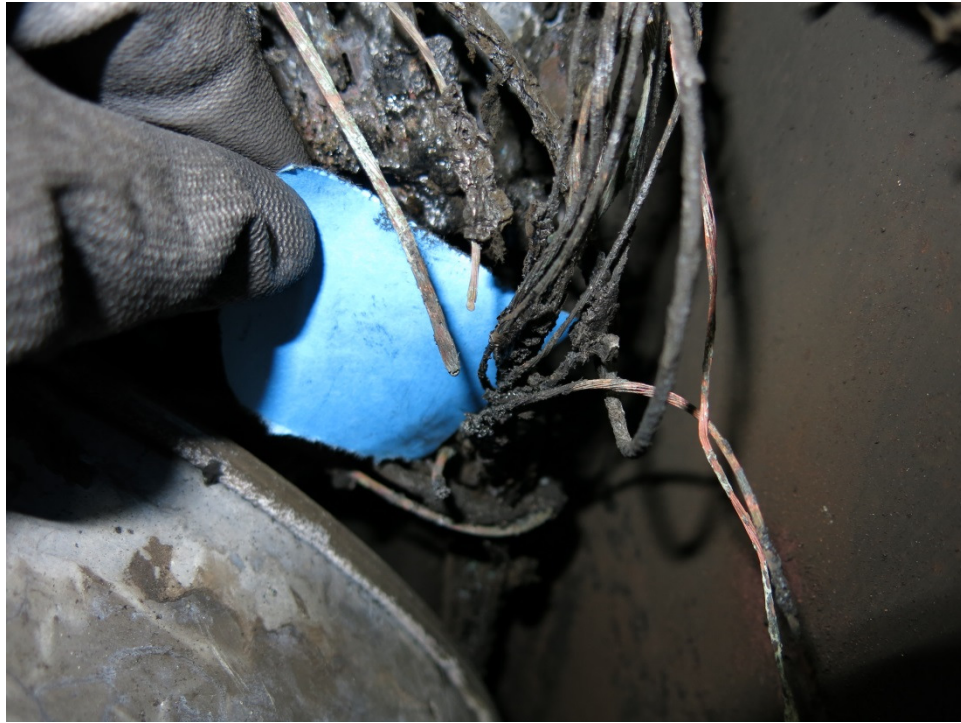
D14509-0309

Figure 42. Beaded wires at rear bulkhead entry.

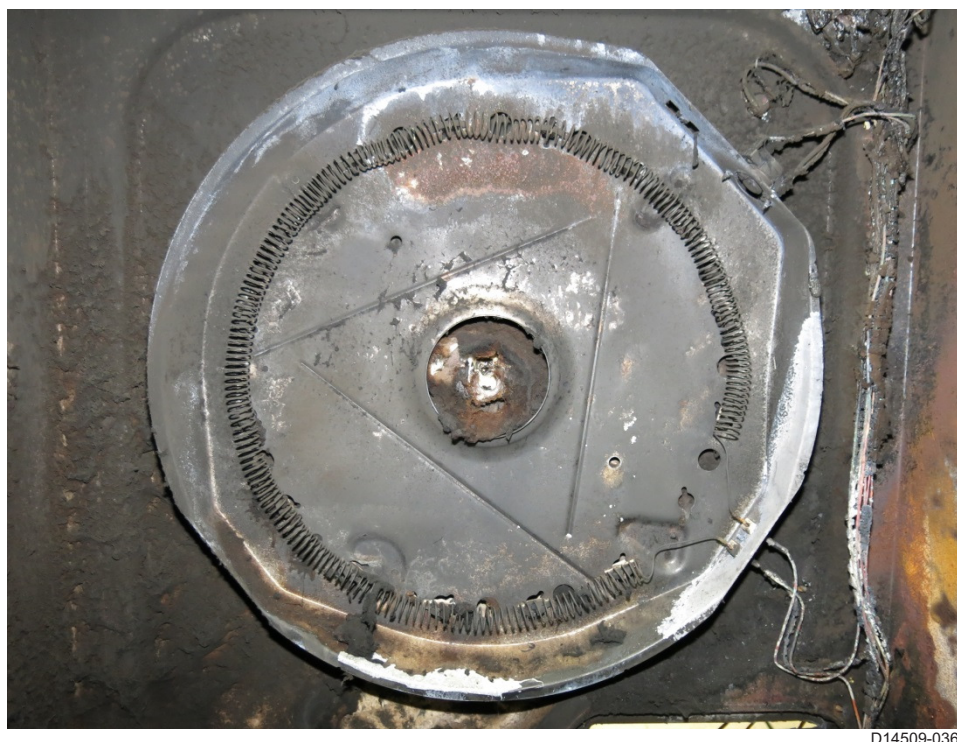
D14509-0369

The heating element was tested for electrical continuity, and was found undamaged and having a resistance of 11.6 ohms. The heating element had not grounded to the heater pan, and there was no indication that electrical activity associated with the electric heater system was the cause of the fire.

Figure 43. Heater pan and heater coil.

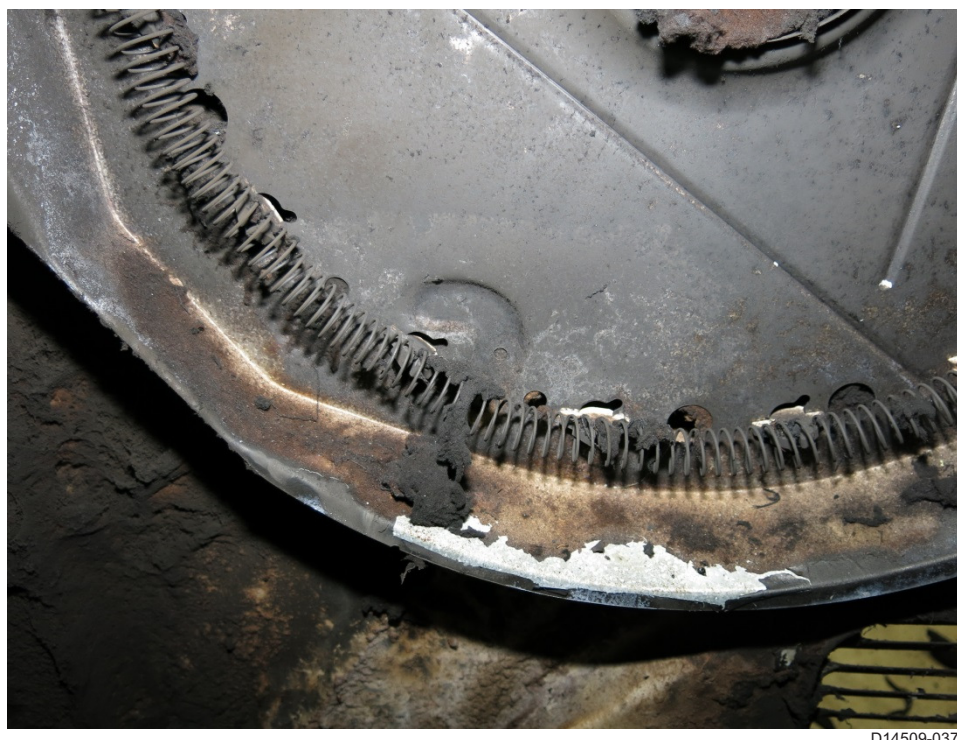
D14509-0376

Some larger agglomerations of lint were found in the base of the heater pan, but likely fell there during suppression efforts or later movement of the appliance. I would expect lint in these locations to have been consumed, had it been located there during operation of the heating element. The Wright Group claimed that this lint “was evidence that the fire was caused when lint that detached from the rear or the drum or from areas where lint had collected in the heater pan above had detached and fallen onto the heating element”. However, they did not explain why this lint was not consumed by the fire, had it been located in this area while the heating element was energized. This ignition mechanism is also inconsistent with the discovery of the fire over 5 hours after the dryer was started, and approximately 4 hours after the heating element would have been de-energized.

Figure 44. Thin coat of lint in the base of the heater pan. The larger agglomerations of lint on and beneath the heating coil were not likely there prior to or during the fire.

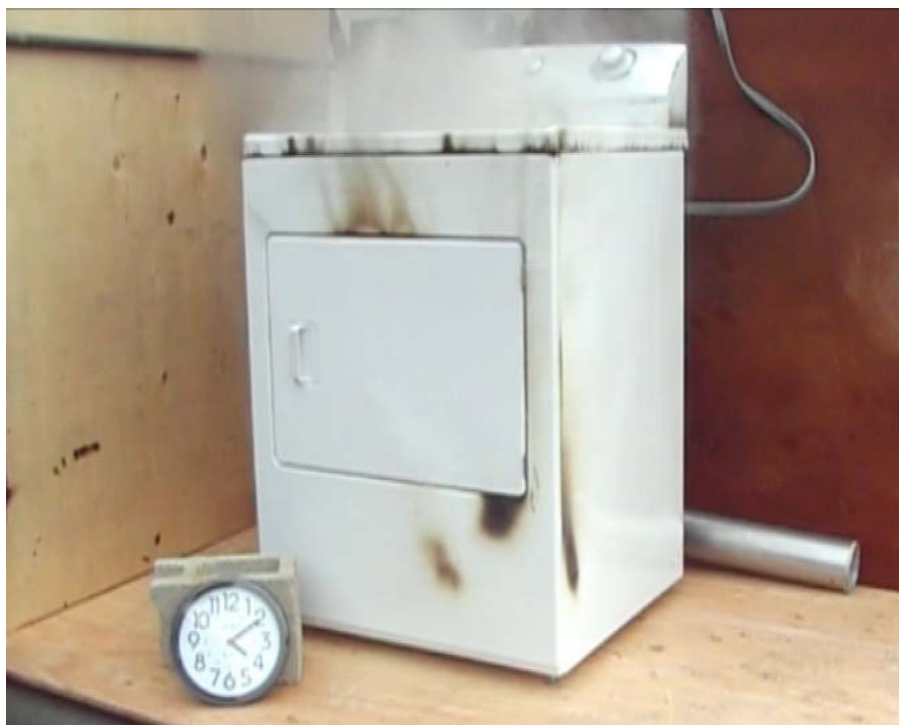
Figure 21. Discoloration of paint.

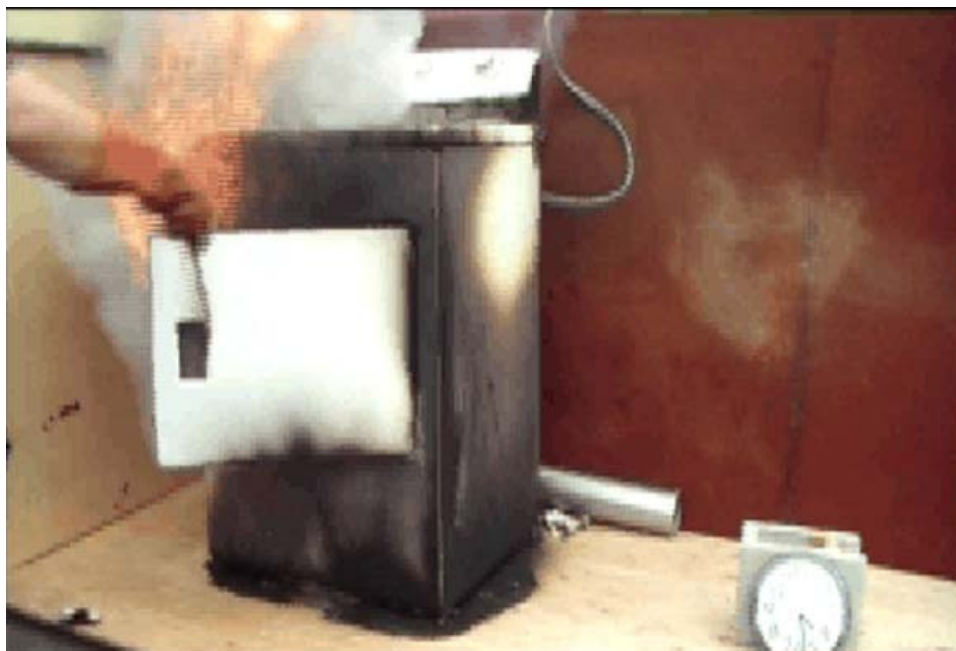
Figure 22. Flames leaving the drum.

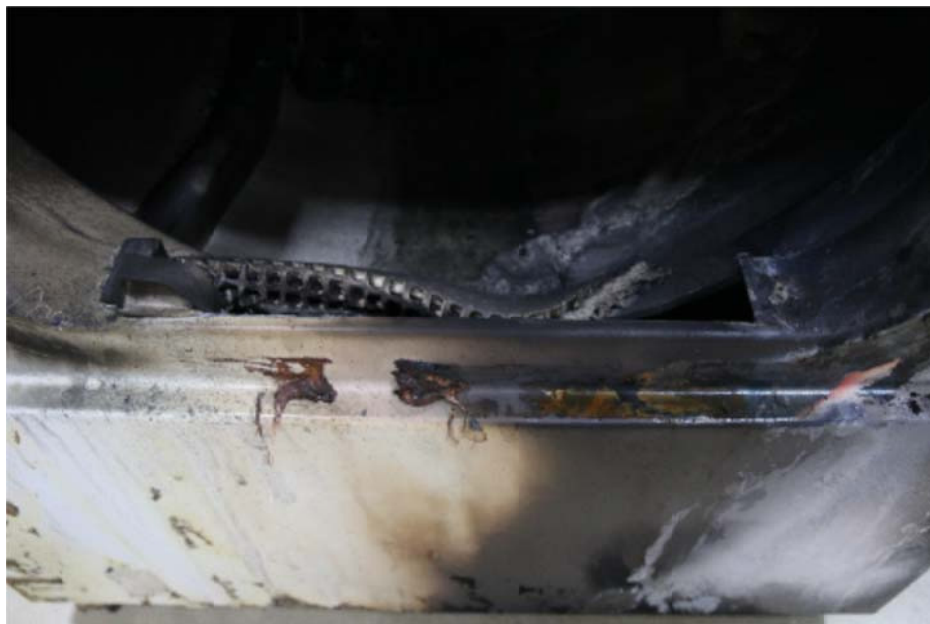
Image 269 from "Burn Test 01_10-31-2013.pdf"

Figure 31. The lint screen has melted and the grill cover for the air duct is melted more toward the right side similar to fire damage patterns observed in past burned Electrolux dryers.

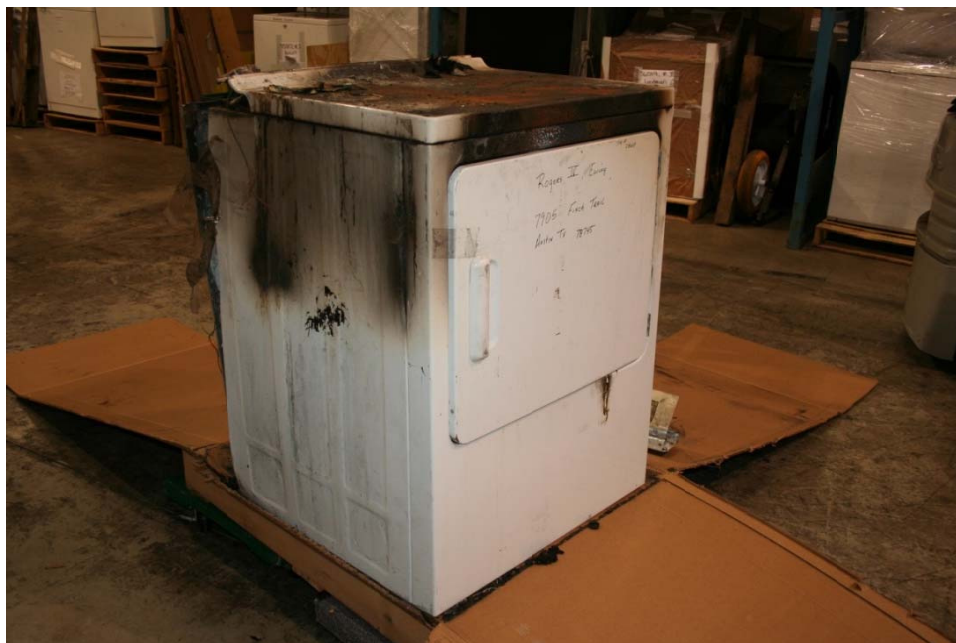
Figure 36. Fire-damaged GE brand clothes dryer -
"WGI#56072_GE_DVLR223EE1WW_ZH755652A."

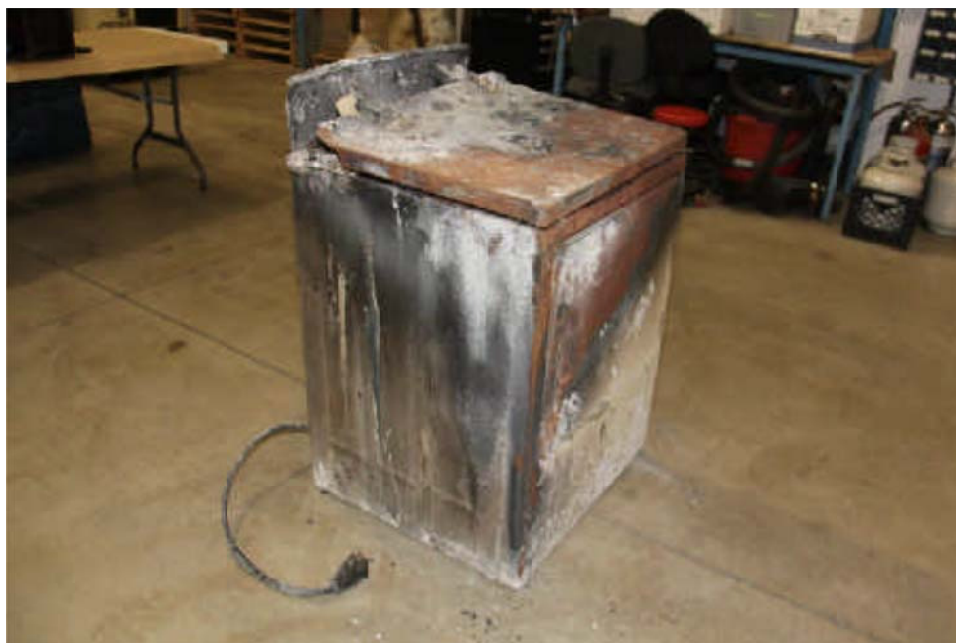
Figure 37. Fire-damaged GE brand clothes dryer - "WGI#58642_
GE_DBLR333EG0WW_AM747632A_Jan 2007."

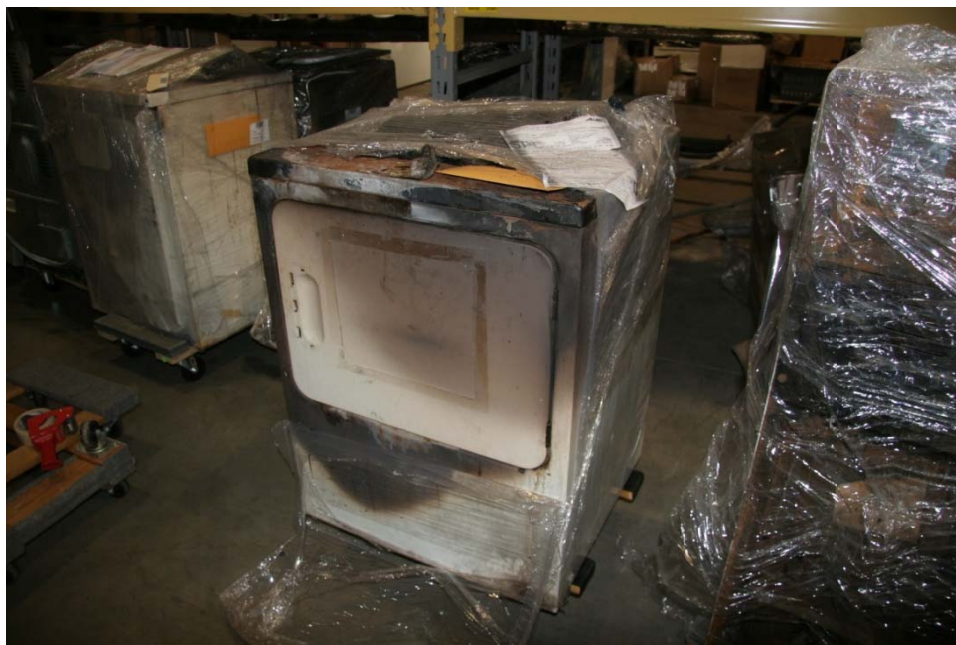
Figure 38. Fire-damaged GE brand clothes dryer - "EXEMPLAR_GE-ELEC-E."

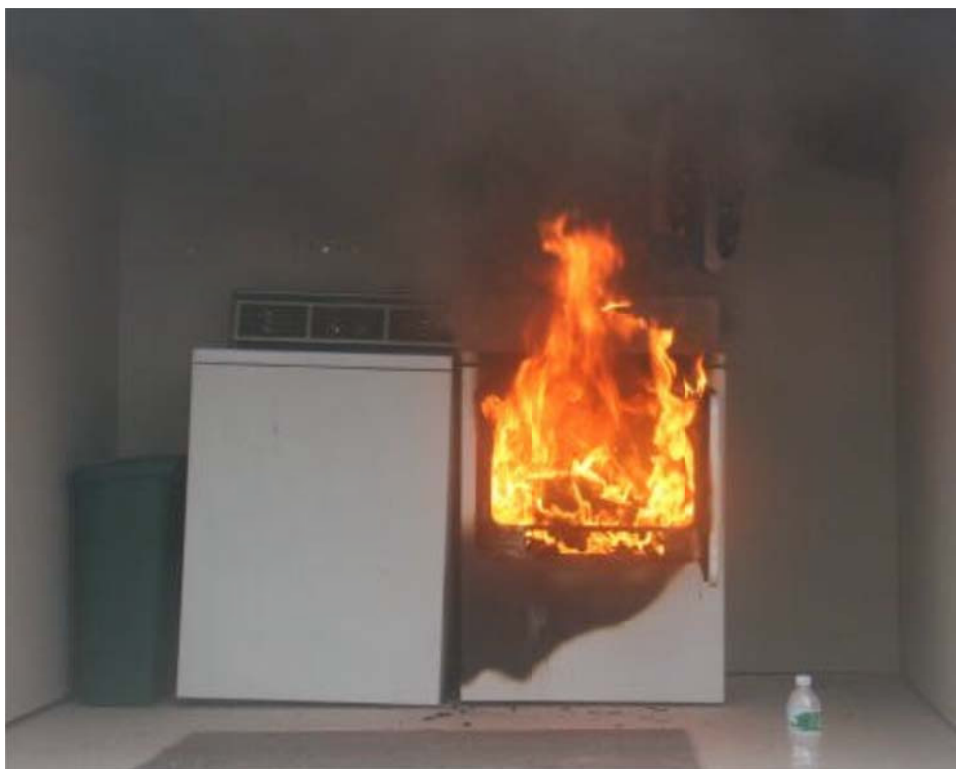
Figure 39. Wright Group drum fire containment test in 2009. The internal fire caused the door to open during the test.
